Opinion paper

Comprehensive assessment of deep-water vessel implosion mechanisms: OceanGate's Titan submersible failure sequence explained

Ruud Weijermars^{a,b,*}^a Department of Petroleum Engineering, King Fahd University of Petroleum & Minerals, KFUPM, Dhahran, Saudi Arabia^b Center for Integrative Petroleum Research (CIPR), College of Petroleum Engineering and Geosciences (CPG), King Fahd University of Petroleum & Minerals, KFUPM, Dhahran, Saudi Arabia

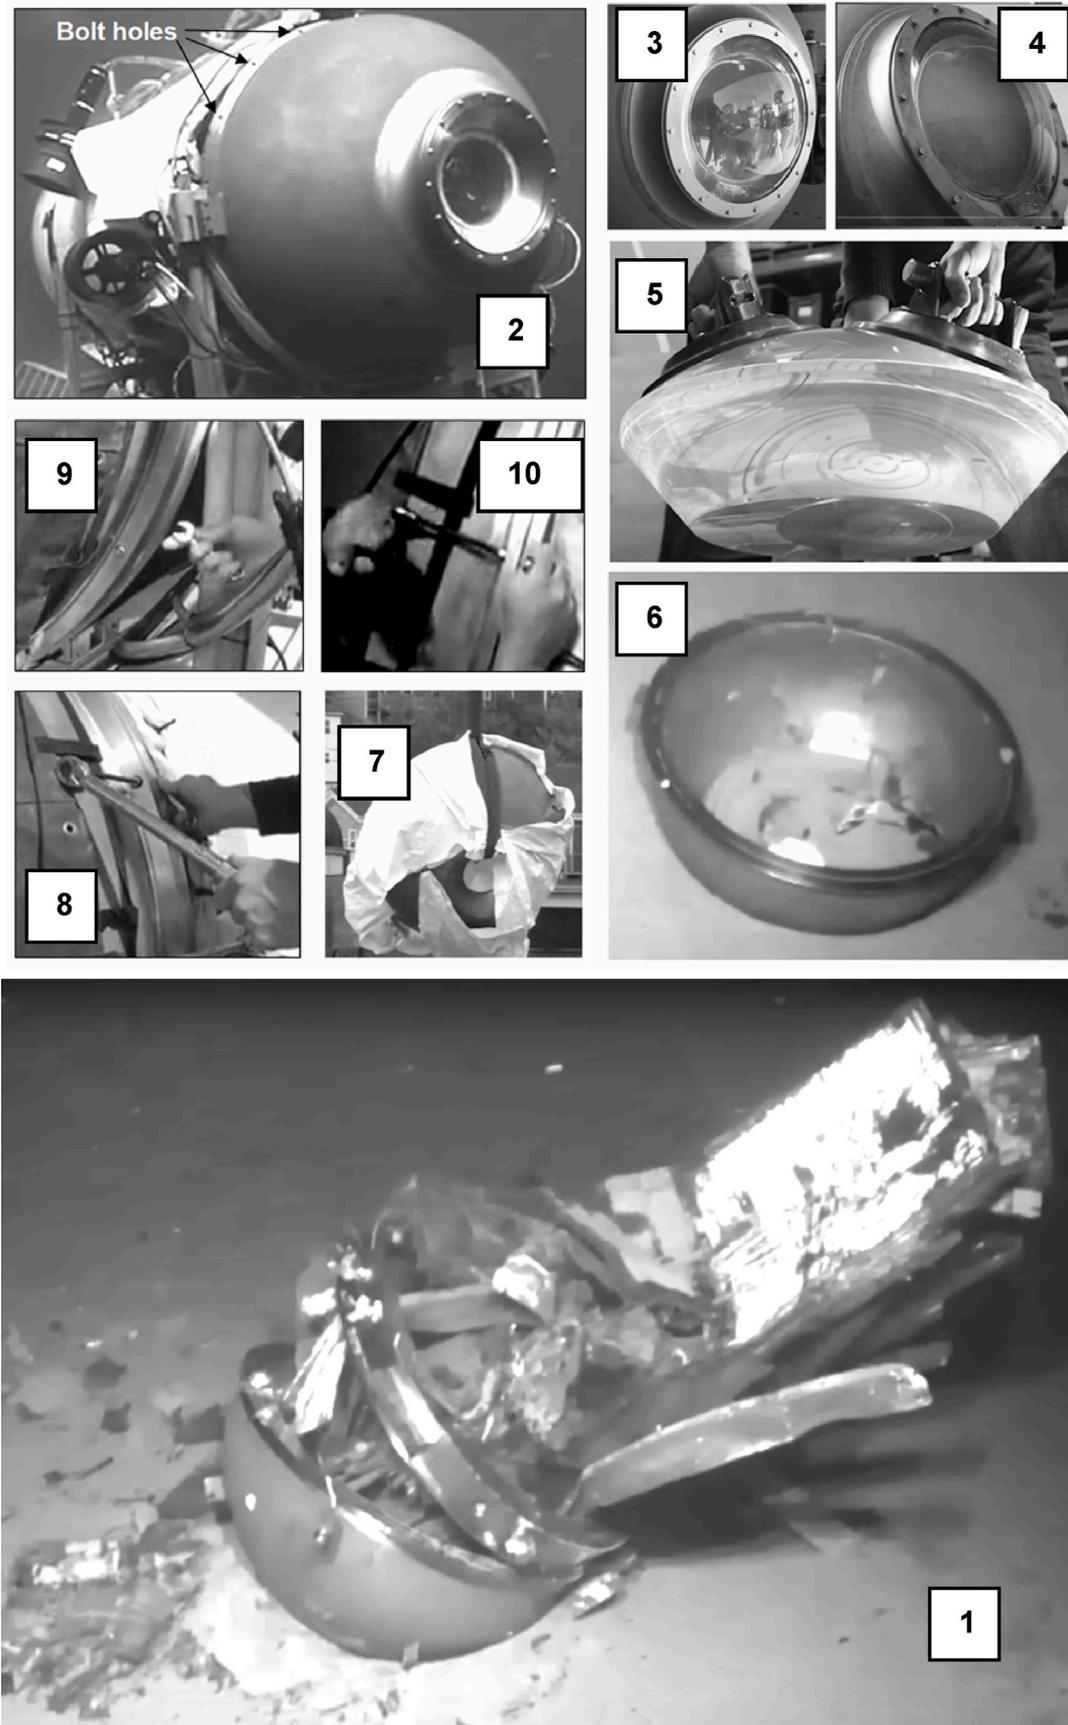
Fig. 3. Video stills from Titan parts before and after implosion [14–16]. Image 1: Imploded rear part of the sub. Images 2–4: Pre-accident front cone. Image 5: Perspex lens before assembly. Image 6: Titanium front cone after implosion; Perspex lens is missing. Image 7: Salvaged front cone lifted ashore. Images 8–10: Bolting of front cone hatch door.

The salvaged Titanium frontal port hatch (seen dangling from a crane in Image 6) has the lens missing. This can also be seen when the port hatch was retrieved from the ocean floor (Image 7). Apparently, the front cone blew off and the lens fell out. But, what is absolutely crucial to note is that the front cone, as it rest upside down on the seafloor, has no longer its Titanium base ring with flange connection to it.

David Pogue, a science correspondent for CBS, who had spent nine days with the sub company, made notion of the fact that there were 18 bolt holes around the hatch, but the crew only used 17 bolts, dismissing the 18th bolt claiming it made no difference [19]. Another known fact is that on a trip prior to the disaster, only 4 bolts were left on the port cone, but these bolts sheared off when the submersible was towed onto the salvage platform along the expedition vessel, and the view port hatch tumbled loose onto the same platform and nearly fell into the sea.

The 17 bolts used to fix the hatch to the Titanium ring (which was in turn glued onto the carbon hull), were affixed by hand using a wrench for the nut and a turning wrench to tighten the bolt (Images 8–10 in Fig. 3). The diameter of the bolts is estimated to have been no more than 8 mm, which must be considered undersized for the shear stresses occurring. Separately, the glue bonds of the multi-bonded carbon fiber

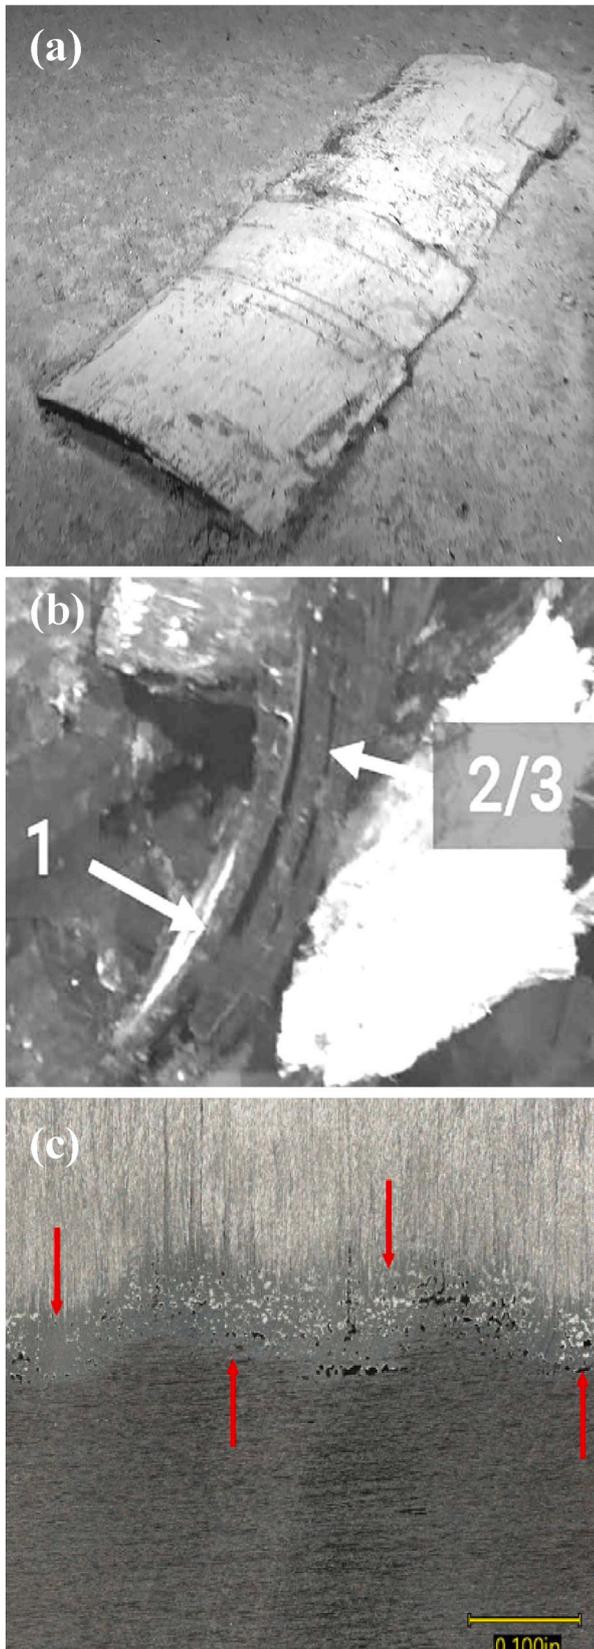
One may now wonder, was the Titan thin-skinned? The answer is, yes, in a way, as explained first here. At the Titan crash site, many signs were observed of delamination or unbonding between the 1-inch thick layers of the 5 layer thick multi-layered carbon fiber hull. Fig. 5b shows one example, where three inner layers of the hull became unbonded, and layers 4 and 5 are outside the field of view, also delaminated. This is very precious diagnostic information, telling us that the delamination process facilitated the inward buckling of panels already thinned by delamination due to cyclic loading during prior dives (see evidence in Section 5.1), actively delaminating as the implosion occurred. If delamination had not happened, the failure would have need to occur in the shear

Fig. 5. (a) Hull fragment (about 2 × 6 ft) is a delaminated slab, inner layer 1 of the carbon fiber hull, which tore along two longitudinal fractures which are known to develop when cylinders buckle inward and reach the failure limit. (b) Extensive delamination was observed of hull slabs retrieved from Titan's debris field (c) Evidence of micro-pores in hull material [14].

There was no mention of heat-induced damage in the material analysis report published by the MBI. However, it is postulated here that a line of pores is seen on the surface of a carbon fiber hull fragment (Fig. 5c), assumedly retrieved from the sea floor, has a toasted appearance. These were simply called pores by the ISB, but are here considered possible degassing pores, created along the contact line of heated (dark portion) of the hull fragment and colder portion (lighter zone) of the hull. In fact, there are dark, scratch like features above the porous degassing zone, which are interpreted here as heat blast markings. However, this is only a speculative observation at this stage.

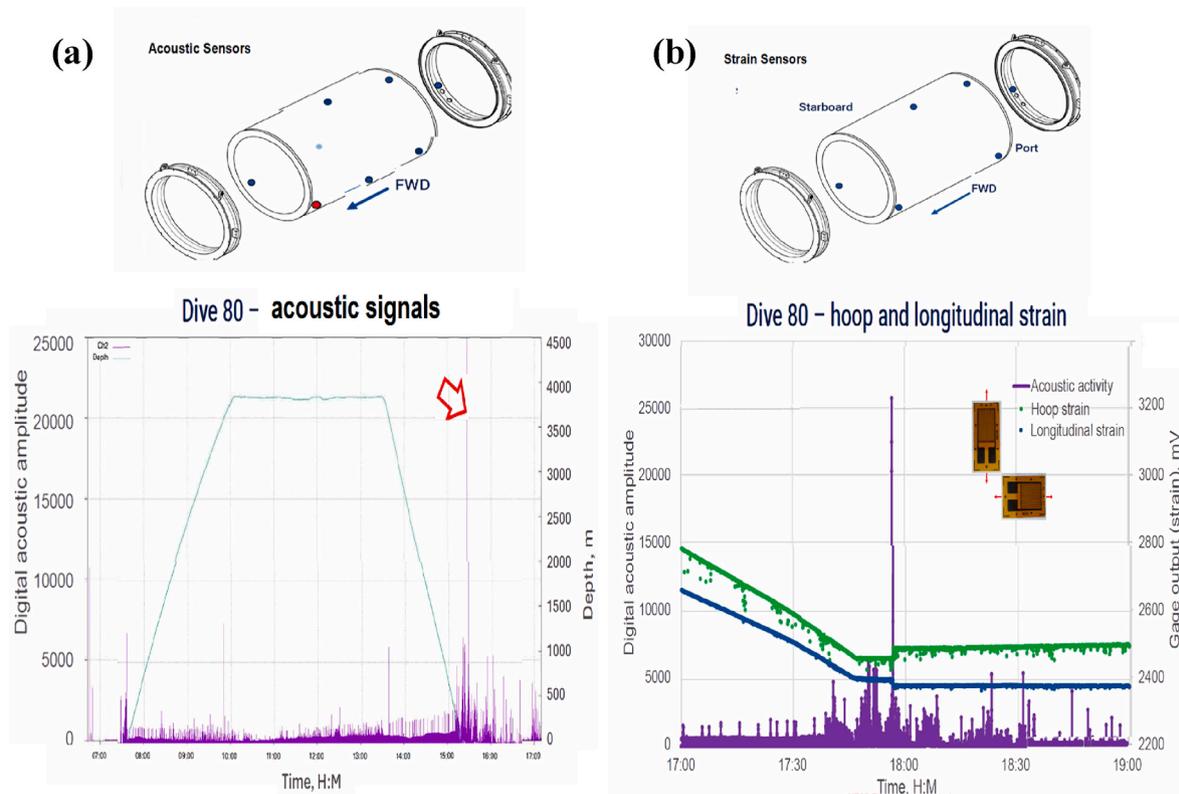
Fig. 6. (a) Dive 80 recording of cracking sounds (purple, amplitude marked on left-hand scale). Green line shows diving depth (marked on right-hand scale). The cracking starts at the beginning of the dive, kicking off with a high amplitude event, returning to lower sounds with a peak amplitude close to arrival at bottom and another peak when the ascend begins. The highest peak occurred after surfacing, a loud ‘bang’ was heard, marked by the red arrow. (b) Strain gauges (measuring mV) for hoop strain (green) and longitudinal strain (blue), show a distinct shift in mV-magnitude after the occurrence of the ‘bang’ sound. The increased differential between the hoop and longitudinal strain would persist on future dives.

heard by the passengers at the end of Dive 80 (on July 15, 2022), after surfacing and it was clearly manifested on the sensor data as well (Fig. 6a).

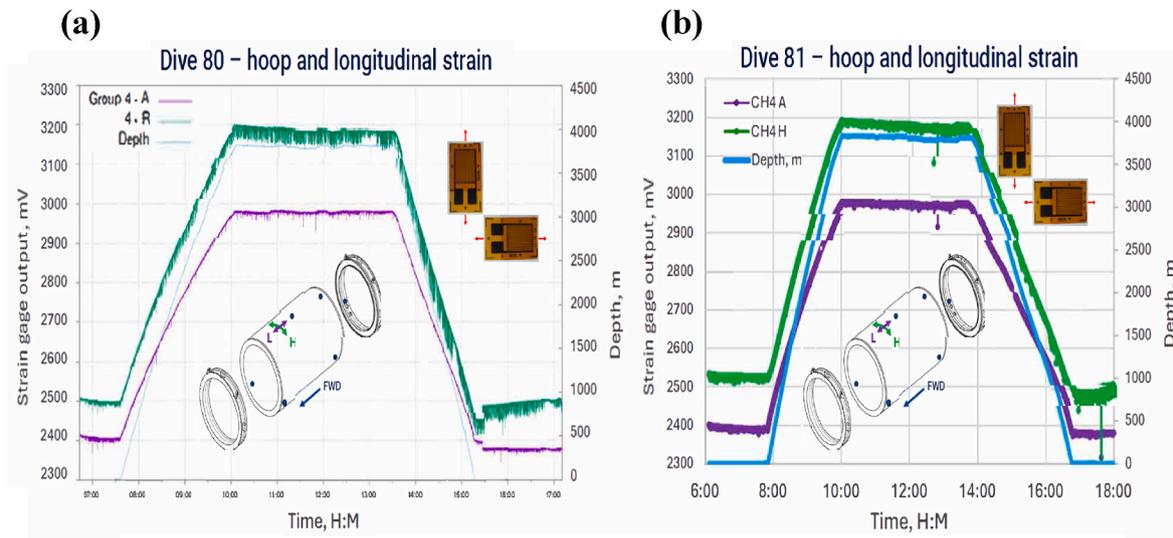
Fig. 7. Hull strain recordings of (a) Dive 80, and (b) Dive 81. The diving to Titanic depths subjected the carbon hull to larger differential stresses as can be inferred from the wider separation between the hoop (green line) and longitudinal strain (purple line) profiles at the seafloor depth. Each dive subjected the hull to cyclically increasing stress loads, which naturally contributed to material aging and fatigue.

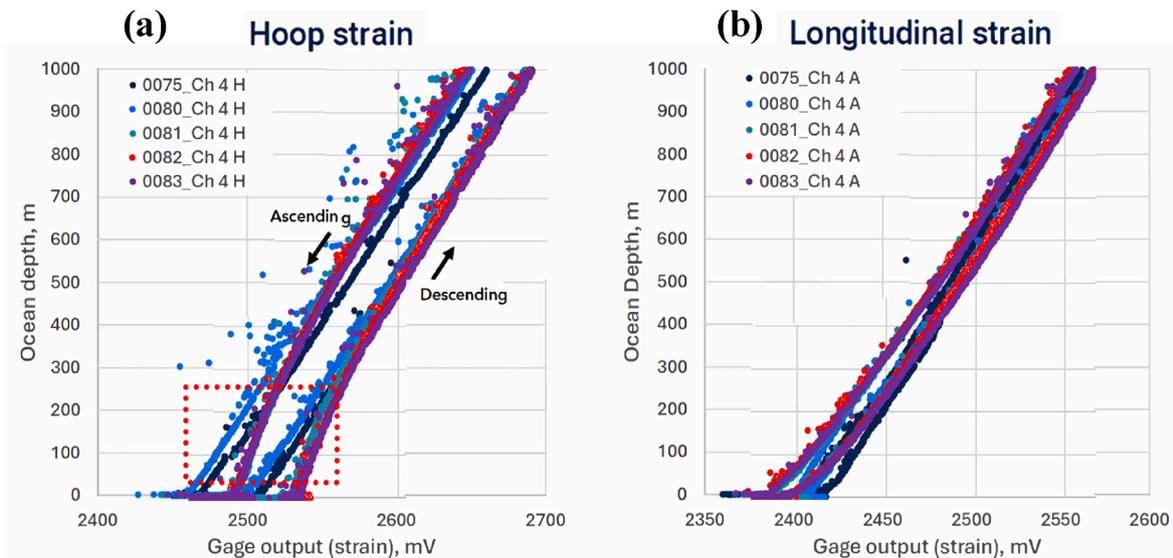
Fig. 8. Comparison of magnified portions of the strain curves for five dives (Dives 75 and 80–83). (a) Hoop strains with dotted rectangular box outlining where the hoop strains in Dives 81–83 were larger than for the previous Dives 75 and 80. The difference is attributed to structural damage after the ‘bang’ sound at the end of Dive 80. (b) The shift in the strain curves is opposite for the longitudinal strains, consistent with what was observed in Fig. 6b.

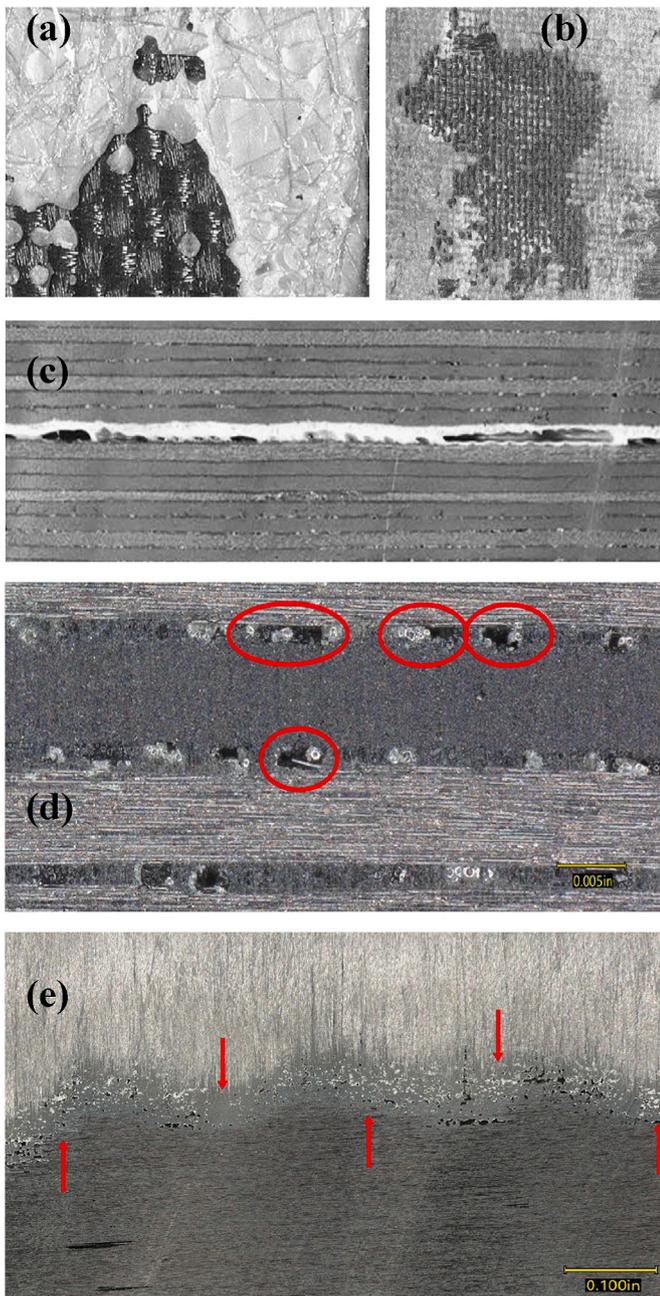
Fig. 9. Principal material analysis findings [14,24]. (a) Random cracks in solidified adhesive layer (top view), (b) Missing glue (map view), (c) Delamination along glue contact (cross-section view), (d) Micro-pores in cross-sectional views, and (e) Micropores as seen from top of hull segment.

bonded layers of the carbon fiber hull, due to deteriorated glue adhesive. The degraded bonding of carbon fiber lamina showed up as cracks in the adhesive layer itself (Fig. 9a), inter-lamina patches where adhesive was no longer bonded to at least one side of the fiber (Fig. 9b), leading to voids (Fig. 9c). The carbon also showed local pores (Fig. 9d). Critically, porosity zones also existed in top view of the carbon hull (Fig. 9e).

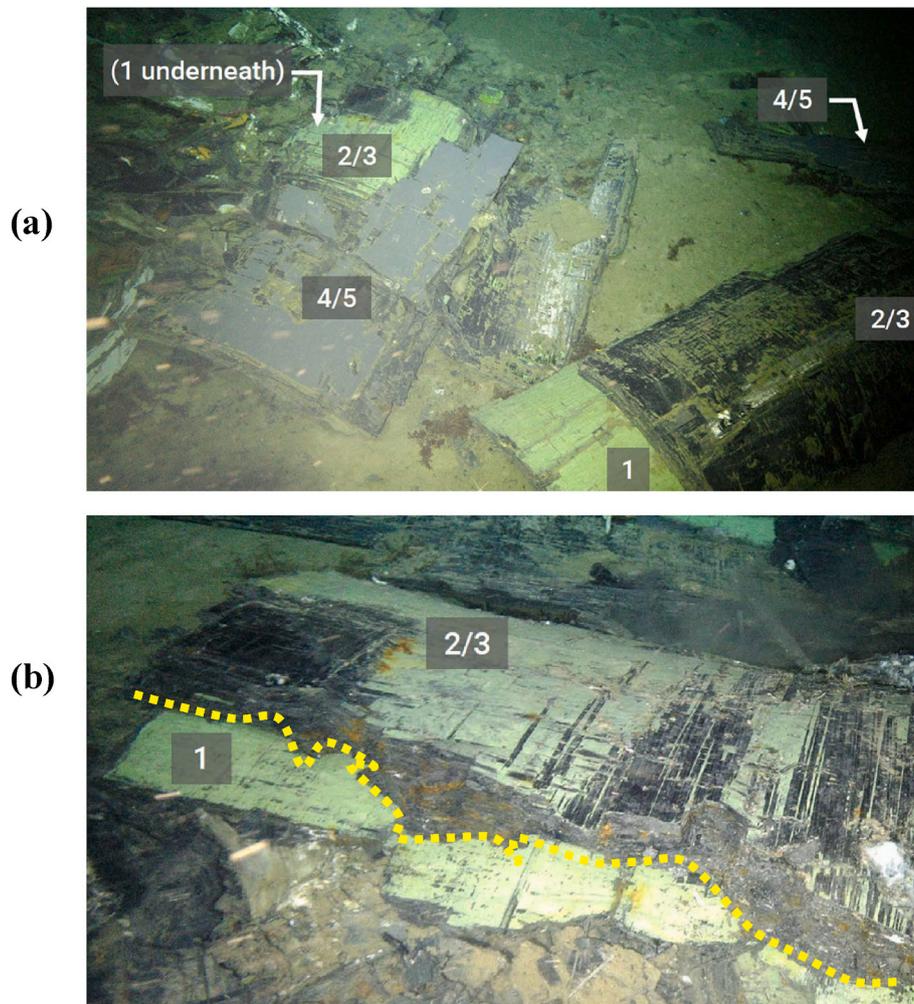
Many large slabs of intact hull fragments were found at the crash site on the ocean floor. These hull fragments appeared more or less rectangular (Fig. 10a) and came off via large longitudinal tear fractures between Layer 1 and composite Layers 2/3, as seen in Fig. 10b. The longitudinal fracture line is consistent with inward buckling of relatively thin, delaminated hull slabs, assisting the failure process during an implosion.

Fig. 10. (a) & (b) Crash site of Titan's debris field with rectangular fragments of delaminated slabs of 5 layer thick multi-layered carbon fiber hull [24]. All layers are 1-inch thick and Layer 1 was originally innermost, and Layer 5 outermost. Dashed curve (yellow) in lowermost image outlines trace of tear fracture at contact between Layers 1 and 2.

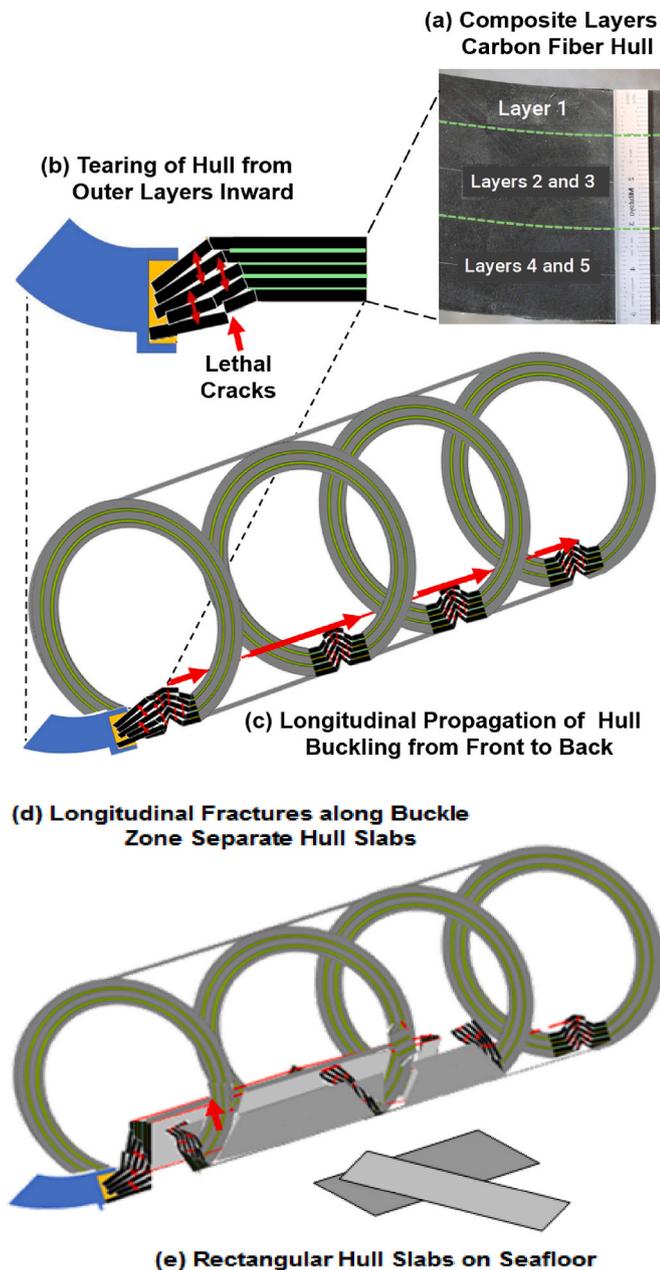
Fig. 11. (a)–(e) Principle sketch of the most likely failure scenario via longitudinal buckling and fracturing. The failure process started with delaminated slabs in the 5-layer thick multi-layered carbon fiber hull. All layers were 1-inch thick and Layer 1 was originally innermost.

- I. Delamination and microfracturing during cyclic loading of successive dives had already separated hull slabs, preferentially along the degraded adhesive between Layers 1 and 2, and between Layers 3 and 4 (Fig. 11a). The preferential separation of these segments can be inferred from the many slabs found on the crash site that had separated along primarily these two joints.

- II. At the final dive, the process of progressive delamination and micro-fracturing was further progressing, starting near the frontal titanium flange (Fig. 11b). In fact, inner Layers 1 and 2/3 did not need to be breached to implode the sub, as inner hull layers would already buckle (Fig. 11c), due to them acting as a thinner tube not built to resist the enormous external pressure loads still increasing as the sub descended deeper and deeper.

- V. Catastrophic longitudinal fracturing of nearly the entire hull occurred (Fig. 11d). The hull was breached, and the air volume inside the sub collapsed. With the hull now massively failing via the longitudinal fractures, the thermodynamic process climaxed as well.

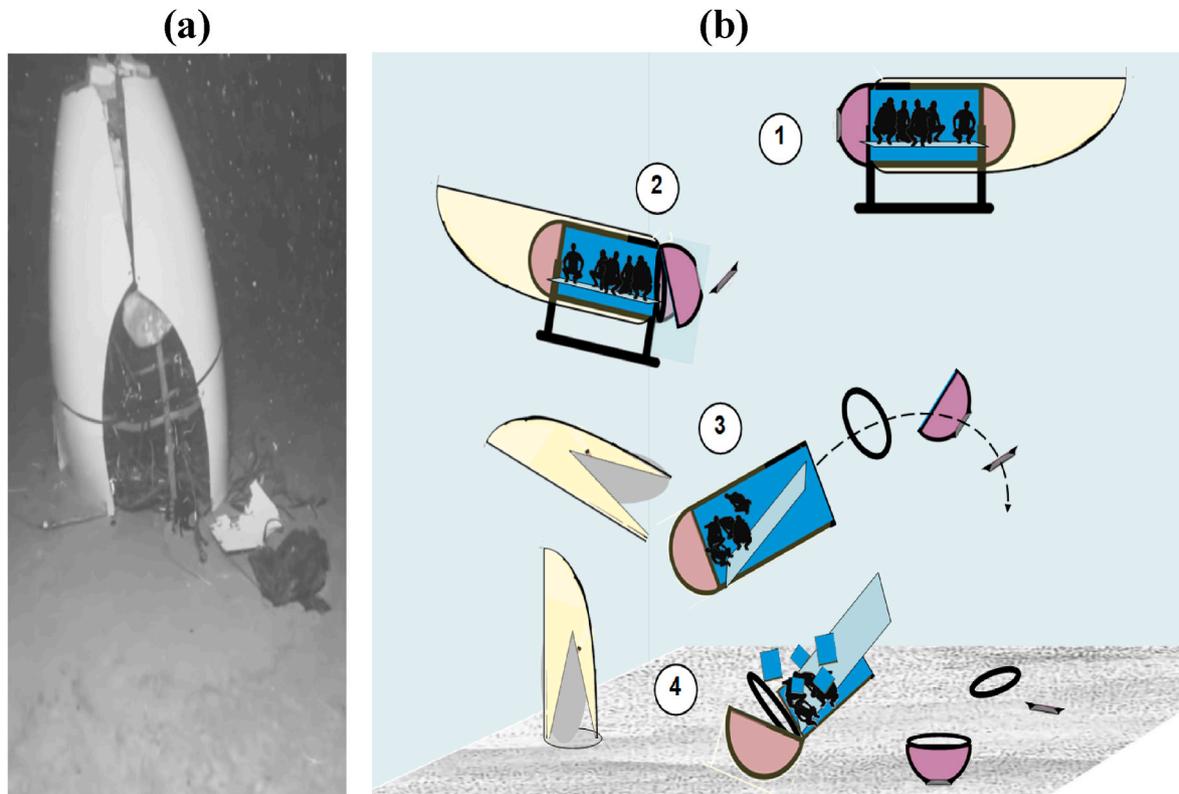
Fig. 12. (a) Crashed exterior jacket of the Titan sub as found on the sea floor. (b) Sketch of events during demise of the Titan sub. Stage 1: Shortly before implosion at about 3500 m depth; Stage 2: Leak near front cone leads to instantaneous implosion (stretched over time in illustration); Stage 3: Hurling away of hull elements during secondary steam-flash driven explosion; Stage 4: Final resting place of wreckage on sea floor at 3777 m. Relative position not to scale.

Fig. 12a shows the exterior jacket of the Titan sub as it was found crashed into the sea floor. The sketch of Fig. 12b attempts to reconstruct the global sequence of events leading up to the sub's implosion. After dropping ballast as conveyed during last contact with the support vessel, the crew said: "all good here" at 10:47am local time on June 18, 2024 (Stage 1). However, the sub most likely had developed cracks through outer Layers 4 and 5 of the carbon fiber hull. Having different loading on the inner Layers 1–3 meant buckling started, and implosion of the vessel's hull was imminent. For illustration purpose the hull's implosion and subsequent explosion processes are unrealistically stretched over time. The Perspex lens blew out almost immediately during the explosion (Stage 2). The sub disintegrated, causing jumbling of the floorboard, the hurling away of the cover wings (yellow), and the primary air implosion and subsequent steam-flash explosion quickly superseded each other (Stage 3). Ultimately, all structural elements landed on the sea floor (Stage 4), where they have been photographed and recovered by remote controlled robots.
