Opinion paper

Comprehensive assessment of deep-water vessel implosion mechanisms: OceanGate's Titan submersible failure sequence explained

Ruud Weijermars^{a,b,*}^a Department of Petroleum Engineering, King Fahd University of Petroleum & Minerals, KFUPM, Dhahran, Saudi Arabia^b Center for Integrative Petroleum Research (CIPR), College of Petroleum Engineering and Geosciences (CPG), King Fahd University of Petroleum & Minerals, KFUPM, Dhahran, Saudi Arabia

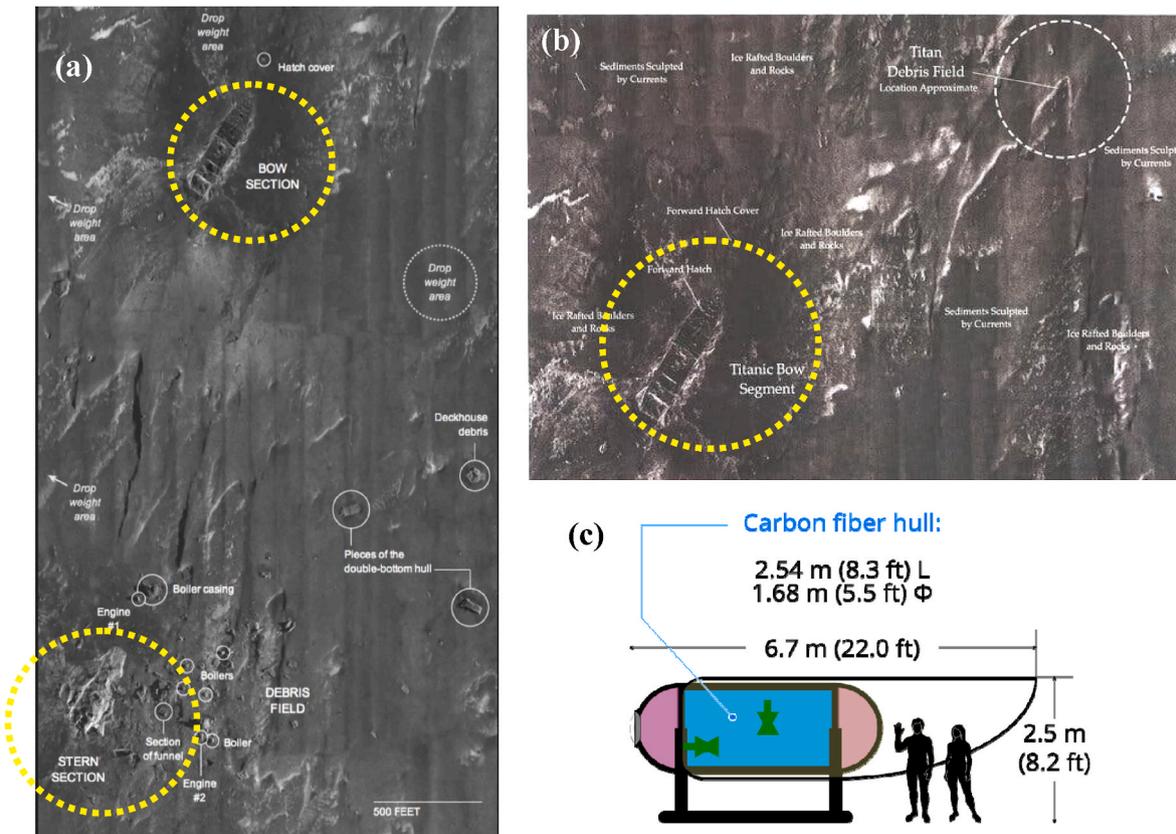
Fig. 2. (a) Left map: Wreckage and debris field showing the final resting place of Titanic’s stern and bow sections [17]. (b) Upper map detail with position of Titan sub’s debris field relative to the Titanic’s bow section wreck [17]. (c). Schematic of the Titan submersible, with dimensions [18].

The hull of the Titan (Fig. 2c) was comprised of a cylinder made of carbon fiber (blue segment) capped at either side by Titanium domes (magenta). It has been posited that the Titanium rings glue-bonds to the carbon fiber was the first cause of failure. However, we will see that Titan's destruction involved the following principal mechanisms: (A) *Primary Implosion Triggers*, given here in arbitrary sequence: (1) viewport collapse, (2) hull collapse, (3) bonding failure between the Titanium rings and the carbon fiber hull, and (4) failure of bolts that connected the two end caps to the Titanium rings mentioned under (3), and (B) *Secondary Explosion*. Based on inspection of the evidence it seems possible to sequence the failure of structural elements, and reconstruct how this cascaded, instantly, into total loss of the engineered structure.

For clarity, it must be stated that the outer, insect-like wings of the Titan (yellow in Fig. 2c) were mainly hydrodynamic design esthetics, and have little bearing on pressure-withstanding of the functional hull; the pressure chamber segment is the blue cylinder with its Titanium end caps.

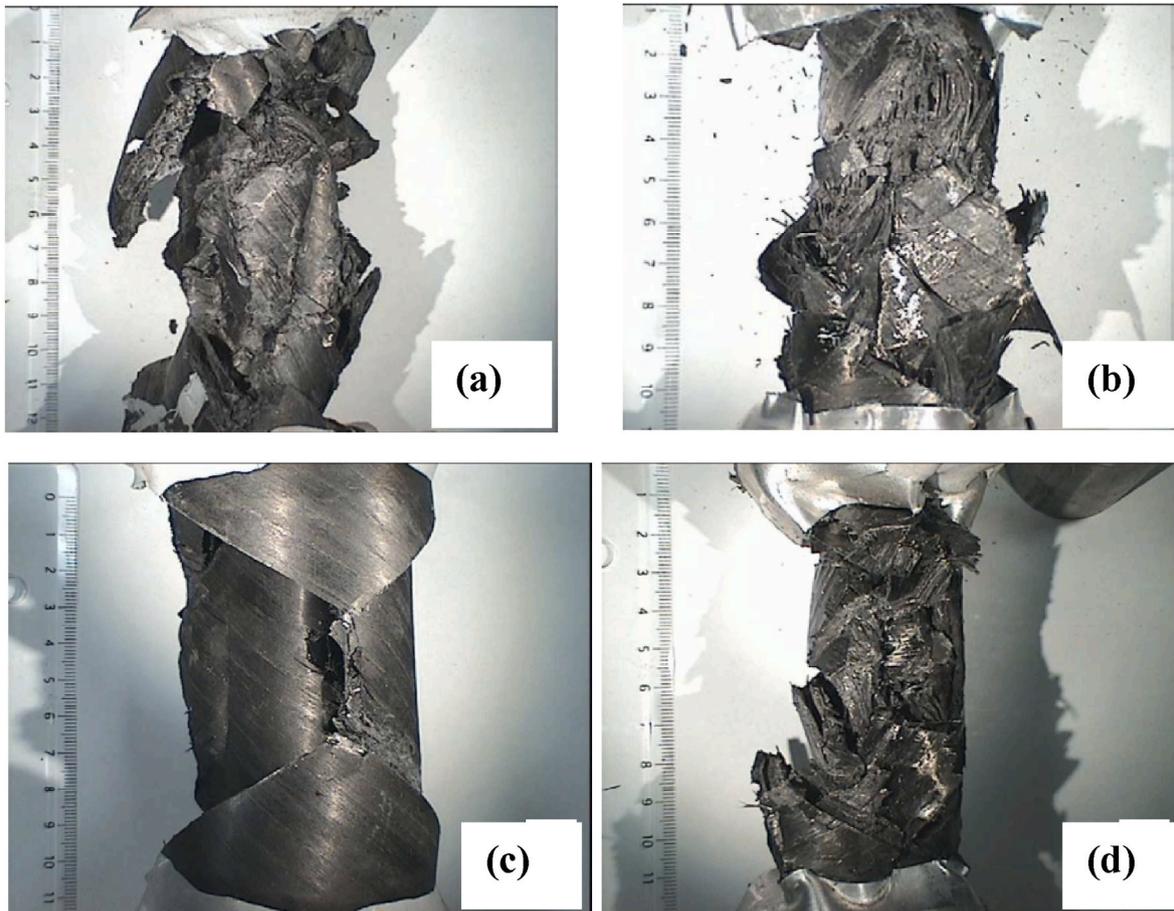
Fig. 4. (a)–(d) Examples of imploded carbon composite tubes from 2005-implosion tests in a 2400 bar pressure vessel [21].

The implosion process of the sub is led by the air volume collapsing from $V = 5.63$ m³ to just 0.0166 m³ or 16.6 L, a 99.7 % reduction of the original air volume (Section 4.1). As the air collapse occurs, the hull will buckle due to the compounded effect of the external positive pressure on the hull and the negative pressure due to air collapse inside. In fact, scaled implosion tests on carbon fiber tubes were originally published in 2005 [21] (many years prior to the Titan development), shown here in Fig. 4.

The experiments of Fig. 4 showed relatively thick-skinned tubes (which are stronger than thin-skinned ones), which develop primarily shear-like fractures created by the large differential between the hoop and the longitudinal stresses when implosion occurs. In contrast, many rectangular hull panel fragments (Fig. 5a) were found at the Titan debris field location. These panels came off the tubular hull via large longitudinal tear fractures. Such fractures are consistent with inward buckling and failure of tubes with relatively thin skins during an implosion [22, 23].

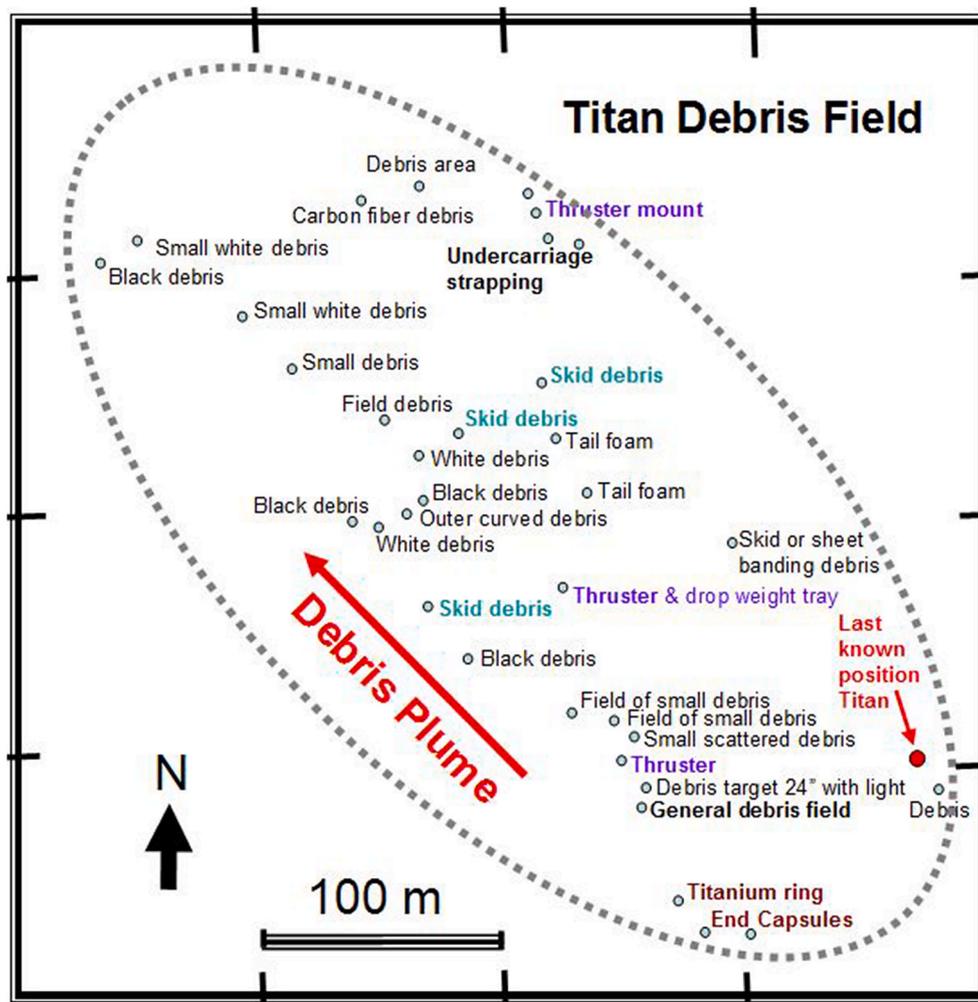
Finally, it is to be expected that the Perspex lens, which was not salvaged, lies intact on the ocean floor, because of its minimal bolting (as it was well supported at its base against inward forces, but not for outward forces, as these were not expected to occur). The eye can be found very close to the end caps (Fig. 13), which were recovered June 2024. The location of the frontal 'End Capsule' (also retrieved) has the following coordinates: 41 44.04568 N; 49 56.53634 W. The eye may be a target for future expeditions. It was announced in May 2024 that Larry Connor and Patrick Lahey, founders of Triton Submarines, are developing a 2-person submersible that allegedly can reach the Titanic safely and repeatedly.

Fig. 13. US Navy map of Titan debris field [26], which covers an elliptical plume region about 450 m long and 200 m wide. The red arrow is the approximate sub-oceanic current direction inferred from the plume shape of the debris and the heavy parts (end capsules and metal ring) lying below the last known position of the Titan sub.
